# Manhole Inspection Summary

Manhole # S19Y\_\_016MH

Insp Date: **6/3/08 12:15 PM**

**Location** Address: **2506 washington-james alley**

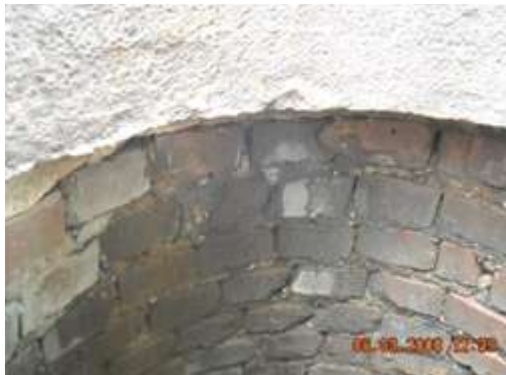
Defect 5

Infiltration: ☐ None ☒ **Joint** ☐ Cracks ☐ Mortar ☐ Roots ☐ Wall

infiltration @ chimney/frame joint

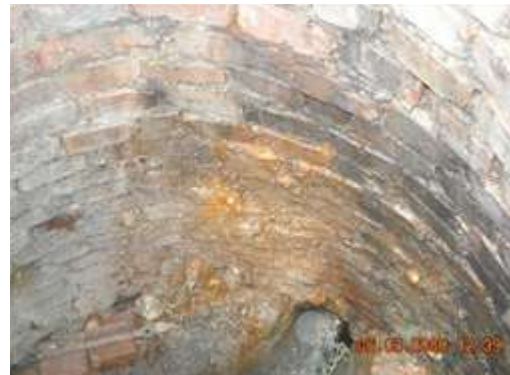
Defect 4

Infiltration: ☐ None ☒ **Joint** ☐ Cracks ☐ Mortar ☐ Roots ☐ Wall

infiltration @ corbel wall and barrel wall,  
bench debris

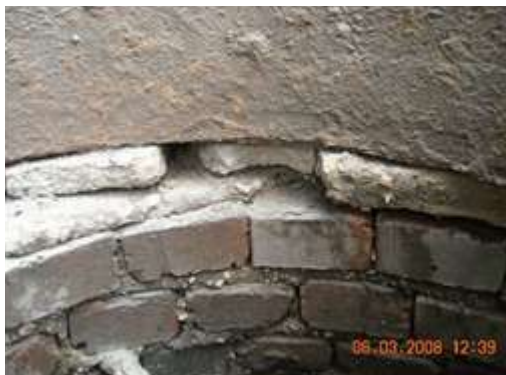
Defect 3

Condition: ☐ Sound ☐ Cracked ☐ Root Intrusion ☒ **Loose Brick** ☐ Deteriorated

loose chimney loose bricks

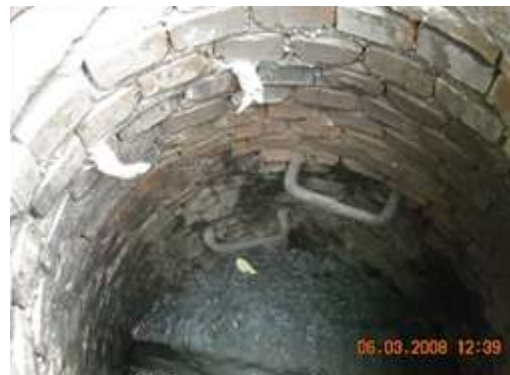
Defect 2

Count: **2** Missing: **1** ☒ **Corroded**

corroded steps

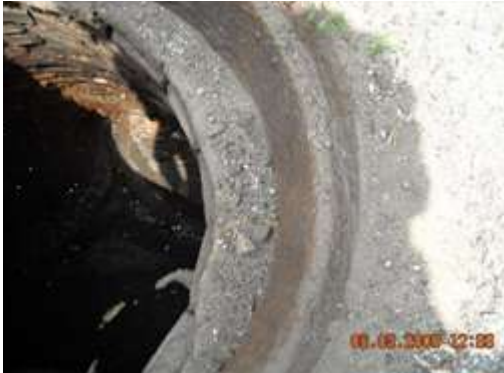
Defect 1

Offset: **2.5** (in.)

frame offset

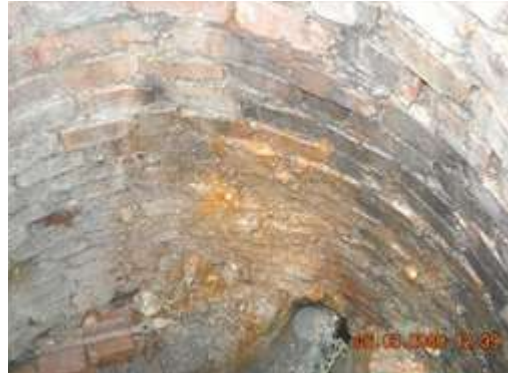
Defect 4

Condition: ☐ Sound ☐ Cracked ☐ Root Intrusion ☐ Loose Brick ☒ **Deteriorated**

Infiltration: ☐ None ☐ Joint ☐ Cracks ☐ Mortar ☐ Roots ☒ **Wall**

barrel condition deteriorated  
Barrel Infiltration through Wall.

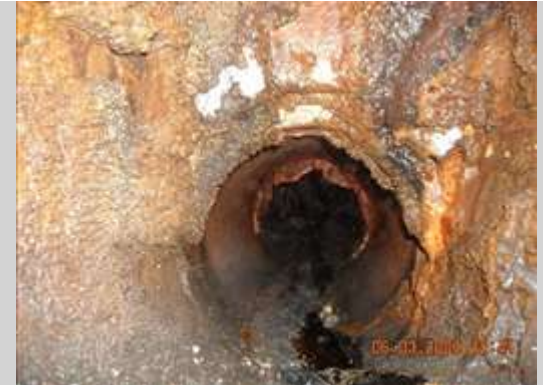
12 O'Clock Outflow

Pipe Height: **8.4** (in.) Rod and Bar (Angled)  
Pipe Material: **Clay** ☐ Pipe Lined  
Invert Depth: **6.83** (ft.) Flow Characteristics: **Slow**  
Deposits: ☐ None ☐ Mud ☐ Sludge ☐ Debris ☒ Grease  
Silt Depth: **2** (in.) Deposits Extent: **Light**  
Infiltration: **None** Pipe Seal Cond: **Unknown**
